Resource Conservation and Recovery Act
Subtitle C, Compliance Evaluation/Land Disposal Inspection

Chevron Baltimore Asphalt Terminal
1955 Chesapeake Avenue
Baltimore, Maryland 21226

Inspected: March 28, 2011
Gerard Crutchley - OECEJ (3EC10)

Final Report - APR 12 2011

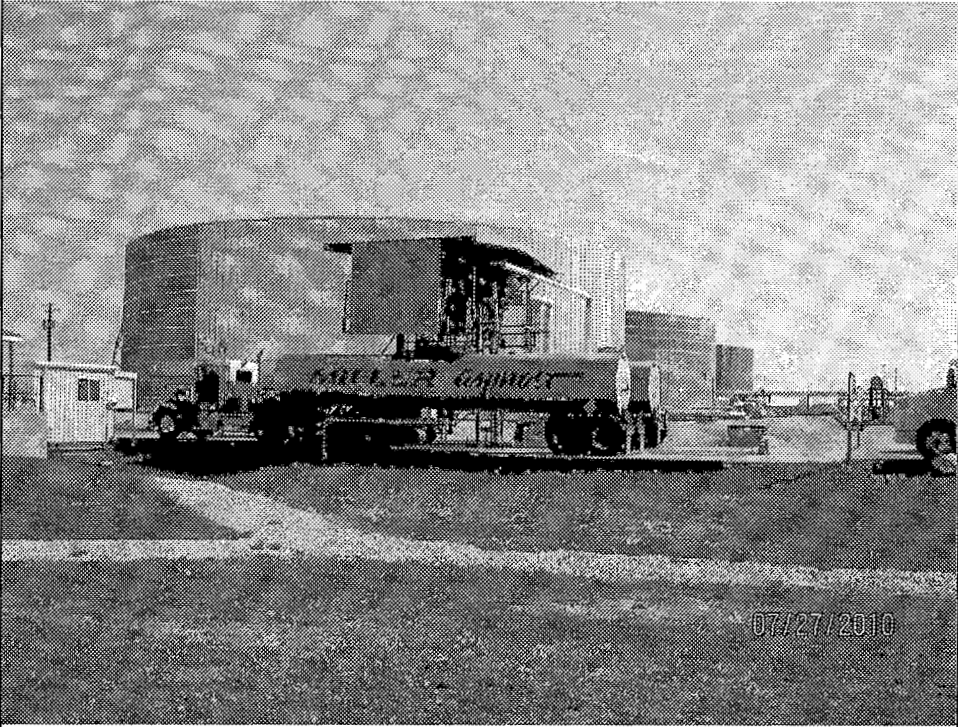
Location:	Chevron Baltimore Asphalt Terminal, 1955 Chesapeake Ave. Baltimore, MD 21226						
Photographer:	Michele Bynum			Witness:	n/a		
Photo #	1	Of	2	Date:	7/27/2010	Time:	9:47 AM
Description:	Chevron Terminal pumping station

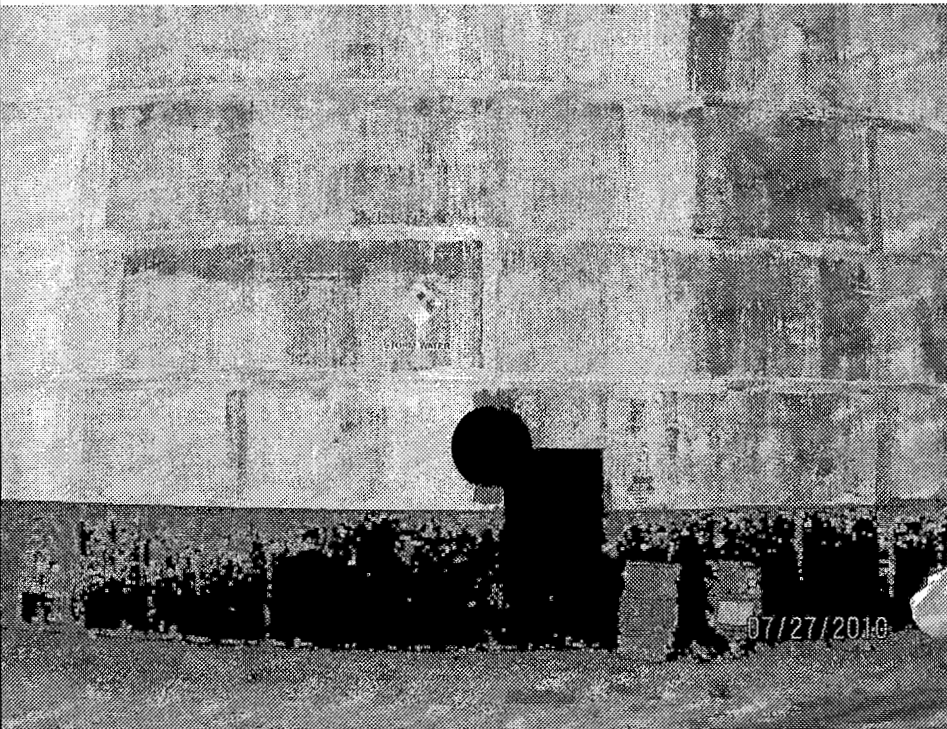
Location:	Chevron Baltimore Asphalt Terminal, 1955 Chesapeake Ave. Baltimore, MD 21226						
Photographer:	Michele Bynum				Witness:	n/a	
Photo #	2	Of	2		Date:	7/27/2010	Time: 9:50 AM
Description:	Decommissioned tank

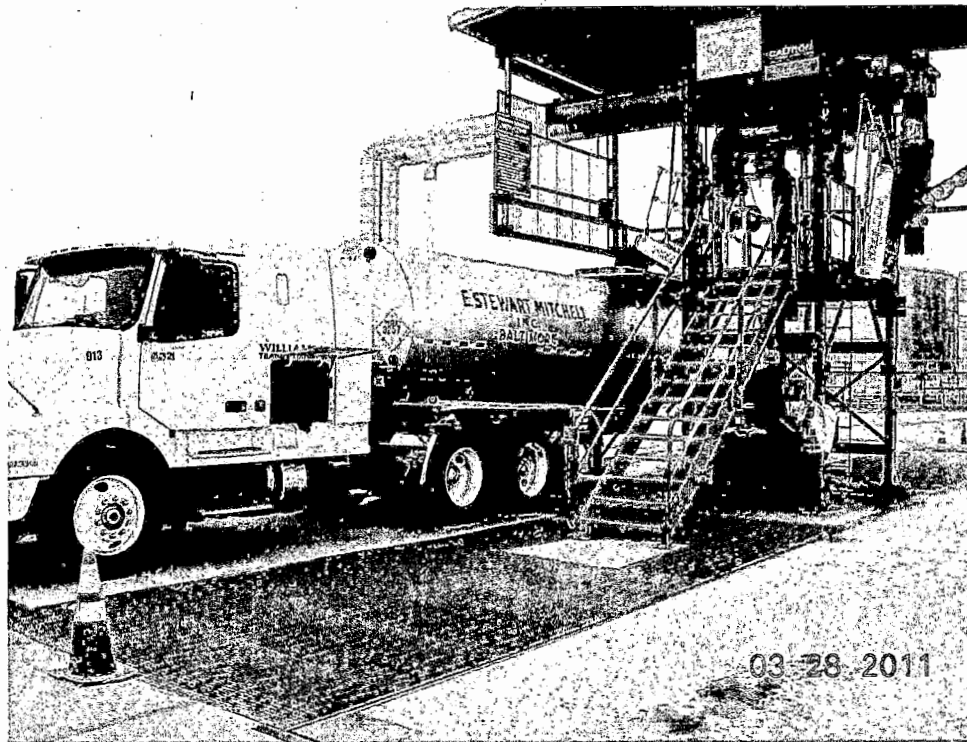
Photo No. 1 – Chevron Baltimore Asphalt Terminal

Following these discussions, the EPA and State inspectors accompanied by the facility personnel toured the facility to observe the operations as described by Mr. Jennings. Just outside of the facility's office is the truck loading station (See Photo No. 1). Mr. Jennings said that the loading is based on weight. An empty truck entering the facility is first weighed and then pulls up to the load station. Once filled, the truck is again weighed and that determines the cost for each shipment. Mr. Mondowney said there is no waste generated at this location. He did say that small amounts of liquid asphalt might drip from the truck fill lines, but the facility uses 5 gallon metal buckets to capture the drips (See Photo No. 2) and that material is then placed back into storage. Beyond the truck loading area, the EPA inspector observed the three 150,000 barrel storage tanks (See Photo No. 3) located on the north side of the facility, and just to the south of these tanks, the inspector observed the 55,000 barrel storage tank (See Photo No. 4). The inspectors did observe a large out of service tank on the east side of the property (See Photo No. 5). Mr. Jennings said that this tank is the one that contained the hazardous waste that was removed from the facility in 2009. Mr. Jennings and Mr. Mondowney both pointed out an open area between the storage tanks that is used as the facility's less than 90 day accumulation area (See Photo Nos. 5 & 6). On the south side of the property, the inspectors observed the oil/water separator unit which, according to Mr. Jennings, collects all of the storm water from the site (See Photo No. 7). The EPA inspector asked Mr. Jennings what happens to any oil that is removed in the separator unit. Mr. Jennings said that they very seldom see any oil in the unit and none has ever needed to be removed from the unit. As discussed earlier during the inspection, the water from the separator unit is pumped to a pond located on east side of the property (See Photo No. 8). The pond has a rubber liner. Water from the pond flows into one of two large standpipes located adjacent to the pond. The water in this pipe eventually rises and then overflows into a second standpipe (See Photo No. 9). The water from this standpipe is then discharged to the Patapsco River (See Photo No. 10) as per the facility's NPDES discharge permit.
